THE NOTCH IMPACT BEHAVIOR OF TUNGSTEN

Twenty Second Technical Report

Office of Naval Research Project

December 1963

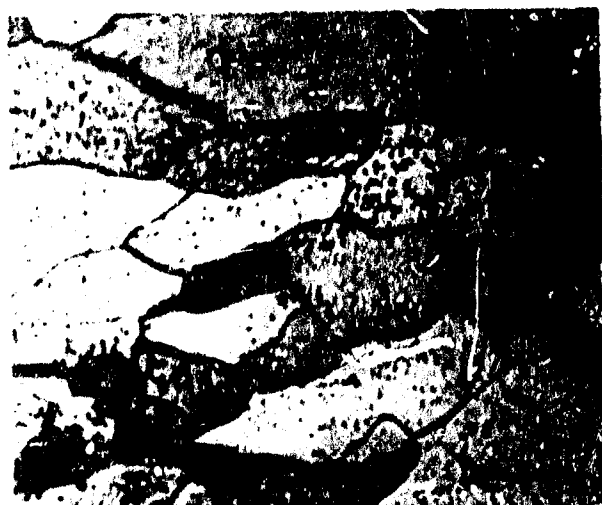
(a) As Swaged

(b) Annealed 8 Hours at 1400°C

(c) Annealed 1/2 Hour at 1600°C

(d) Annealed 1/2 Hour at 2000°C

Figure 1 - MICROSTRUCTURES OF (a) WROUGHT, (b) RECOVERED, AND (c) AND (d) RECRYSTALLIZED TUNGSTEN. (X250)

The microstructures produced by the various anneals were studied both by x-ray diffraction and metallographic techniques. Figure 1 reproduces the microstructures observed metallographically following a 10 second electro-etch in a 10 percent KOH solution. Figure 1(a) shows the elongated fibrous grain structure of the as-received material. Following the anneal at 1300°C or 1400°C the grain structure was still elongated as shown in Figure 1(b) but the etch pits delineated dense polygonized dislocation arrays within many of the grains. Occasionally a relatively dislocation free recrystallized grain was found growing into the matrix. The anneals at 1600°C and 2000°C resulted in complete recrystallization and some grain growth. The grains produced at 1600°C were still slightly elongated as shown in Figure 1(c) whereas the anneal at 2000°C produced equiaxed grains. The changes in grain size produced the expected changes in the x-ray back reflection patterns, there was no indication either in the as-received material or the annealed material of any preferred orientation.

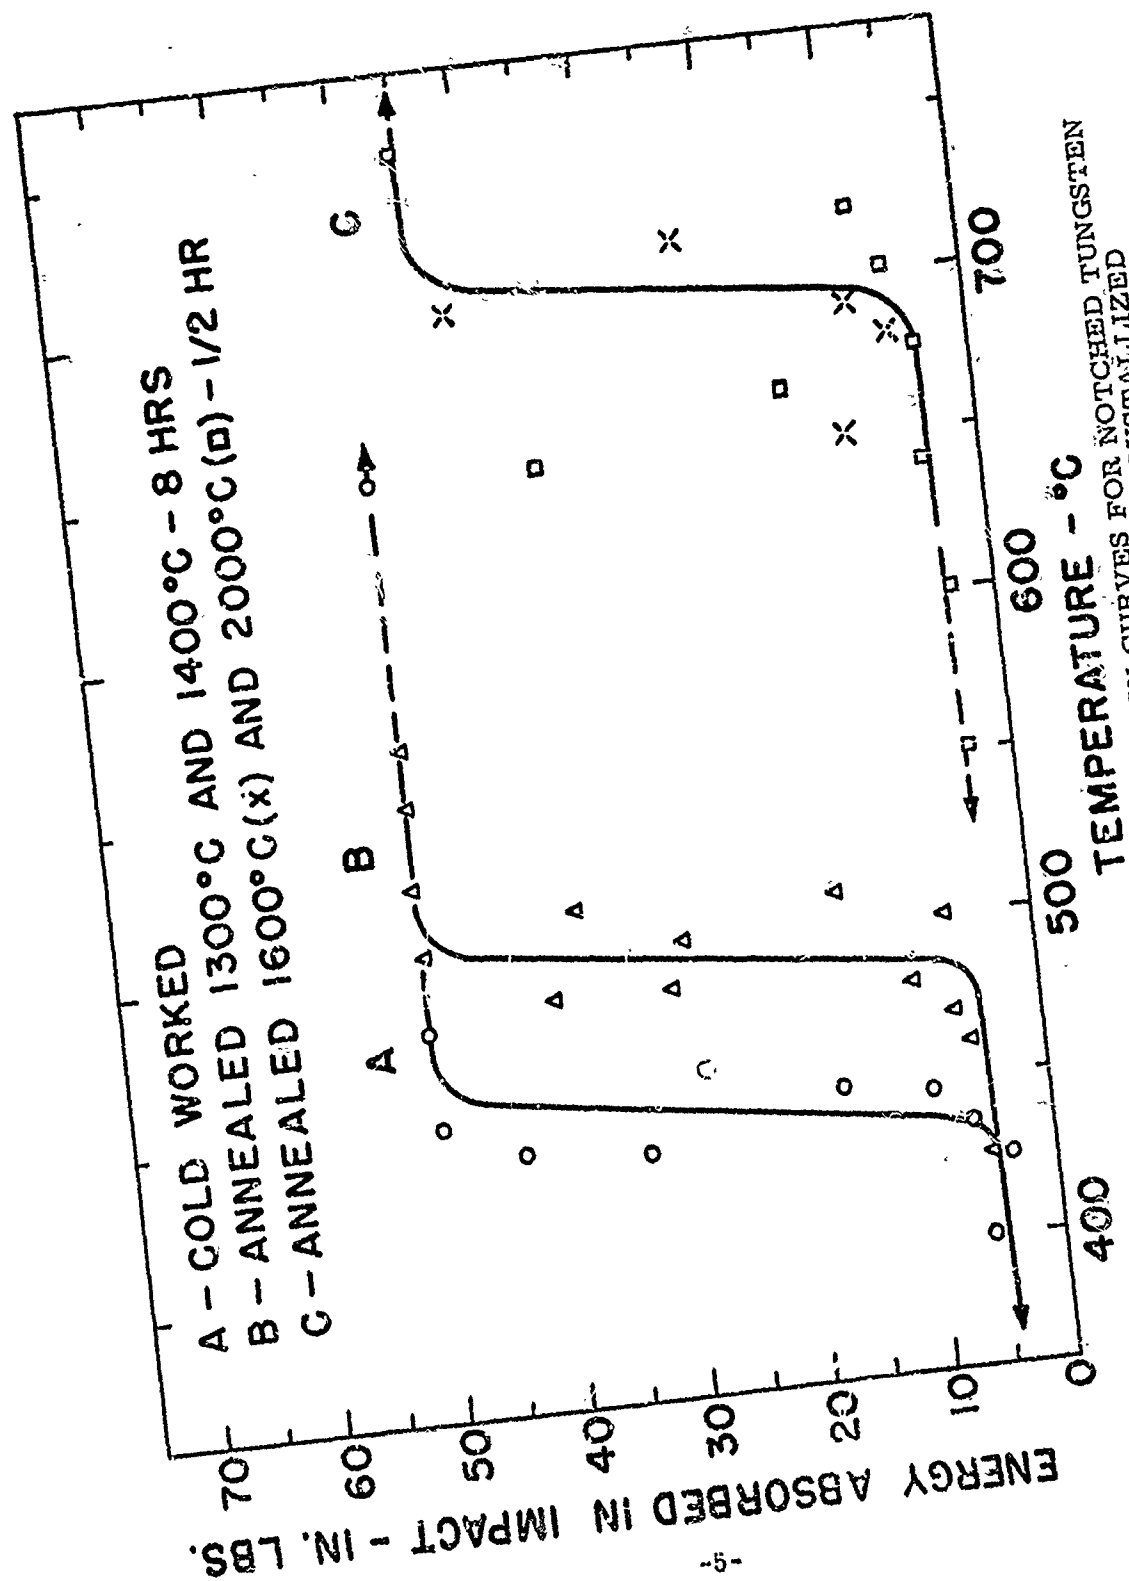
Figure 2 - DUCTILE-BRITTLE TRANSITION CURVES FOR NOTCHED TUNGSTEN (A) WROUGHT, (B) RECOVERED, and (C) RECRYSTALLIZED

Figure 2 reproduces the ductile-brittle transition curves measured in the manner described in the previous section. It can be seen that under these testing conditions the as-received wrought tungsten rods showed a ductile-brittle transition between 435°C and 450°C (curve A, Figure 2), whereas the recrystallized material showed a ductile-brittle transition between 690°C and 710°C (curve C, Figure 2), i. e. an increase of 260°C. The polygonized specimens annealed at 1300°C or 1400°C showed a slight increase of 50°C in the ductile-brittle transition temperature to a value between 480°C and 500°C (curve B, Figure 2).

First we shall describe observations on the recrystallized material (curve C, Figure 2). The fracture surfaces over the whole temperature range for which this material was brittle, i. e. up to 700°C, were flat and normal to the rod axis and thus to the tensile direction. Fracture occurred almost exclusively by cleavage with a limited number of intergranular facets. Whereas the cleavage facets at low temperatures were relatively featureless as in Figure 3(a), cleavage facets at temperatures approaching the transition were accompanied by a high density of tear markings and evidence that crack propagation was proceeding discontinuously. Figure 3(b) illustrates the appearance of cleavage in

The as-received wrought tungsten rods (curve A, Figure 2) and the specimens annealed at 1300°C or 1400°C (curve B, Figure 2) showed a wider spectrum of fracture modes through their respective brittle to ductile transitions. At very low temperatures (i. e. up to 300°C) the wrought specimens fractured predominantly by cleavage with a few isolated regions of intergranular fracture as shown in Figure 4. There were, however, two features which distinguished this low temperature cleavage from that observed on recrystallized material. First, there was a difference in grain size which increased approximately by a factor of 10 in the transverse plane upon recrystallization and second, there was a marked increase in the tear line density. This could have been due to the smaller grain size causing more frequent changes of the fracture plane or due to the higher dislocation density in the wrought material.

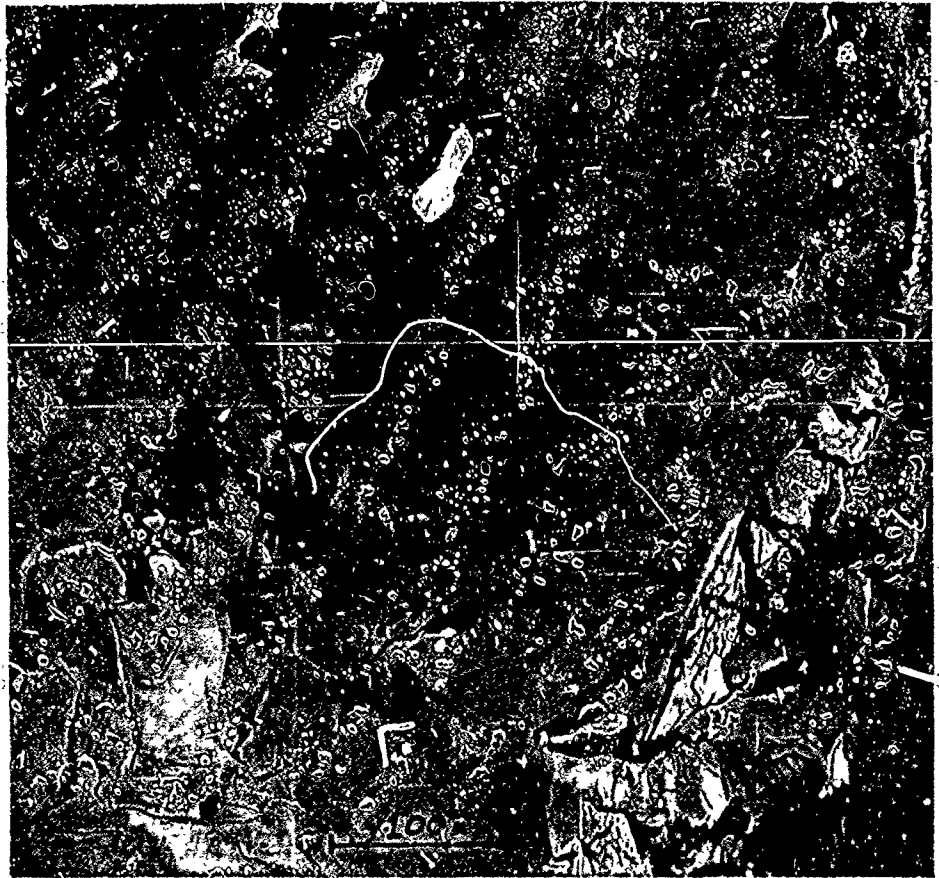
Figure 3a - ELECTRON FRACTOGRAPH SHOWING CLEAVAGE IN  
RECRYSTALLIZED TUNGSTEN AT ROOM TEMPERATURE.

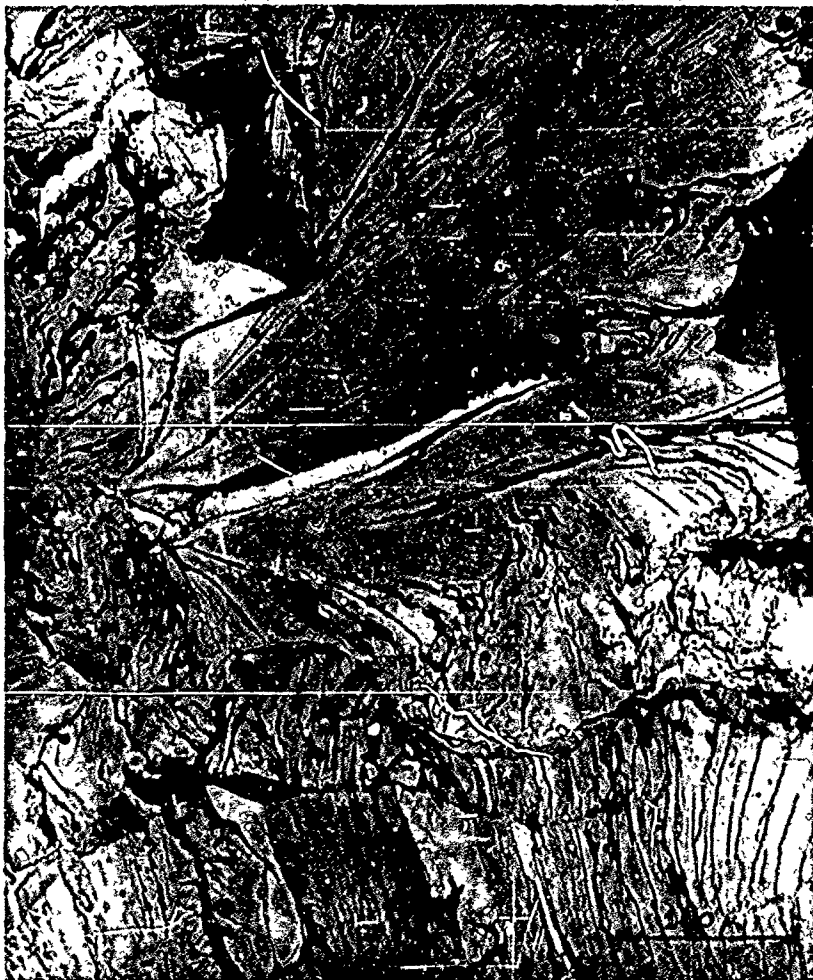
Figure 3b - ELECTRON FRACTOGRAPH SHOWING CLEAVAGE IN RECRYSTALLIZED TUNGSTEN AT 690°C.

recrystallized tungsten at 600°C. The sudden changes in tear line density along a profile corresponding to the crack front in the upper grain of Figure 3(b) indicated discontinuous propagation. In addition it could be seen that fracture in the upper grains was proceeding from left to right and in the lower grains it was proceeding vertically, at the boundary between these two crack fronts there was a narrow zone of plastic tearing. This mode of propagation corresponded to cleavage accompanied by considerable plastic flow at the crack tip, which was to be expected considering the specimen fractured at a temperature only a few degrees below the transition temperature.

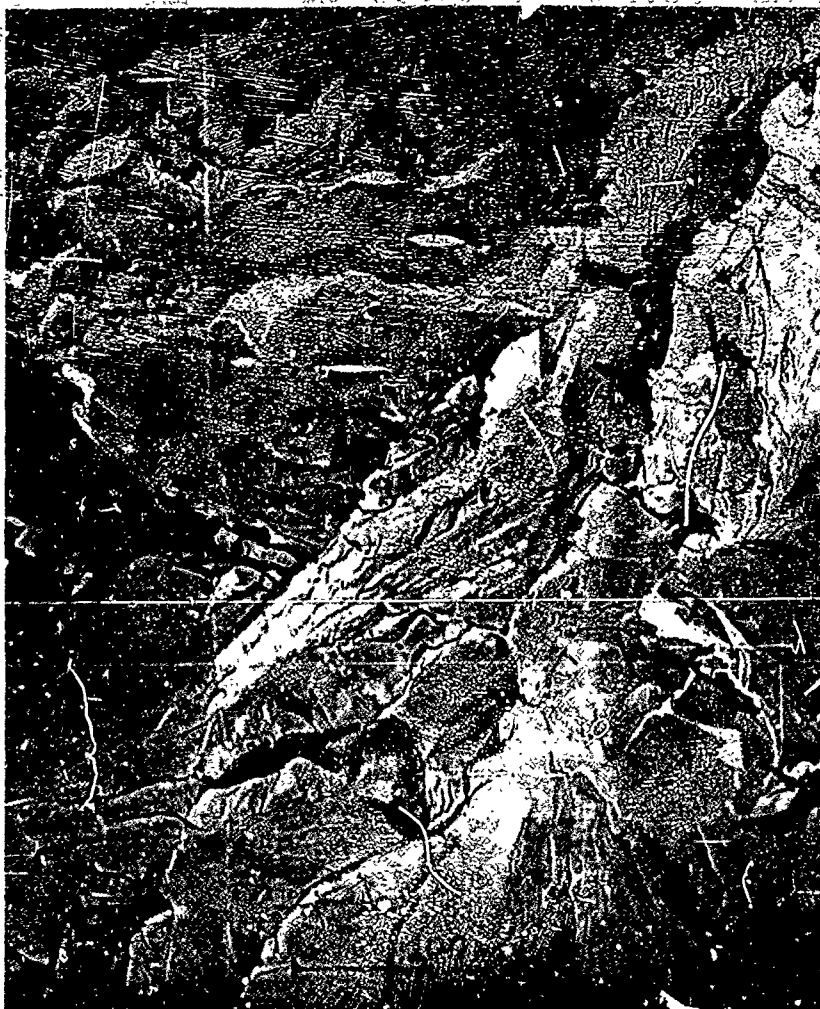
Figure 4 - ELECTRON FRACTOGRAPH SHOWING CLEAVAGE IN WROUGHT TUNGSTEN AT ROOM TEMPERATURE.

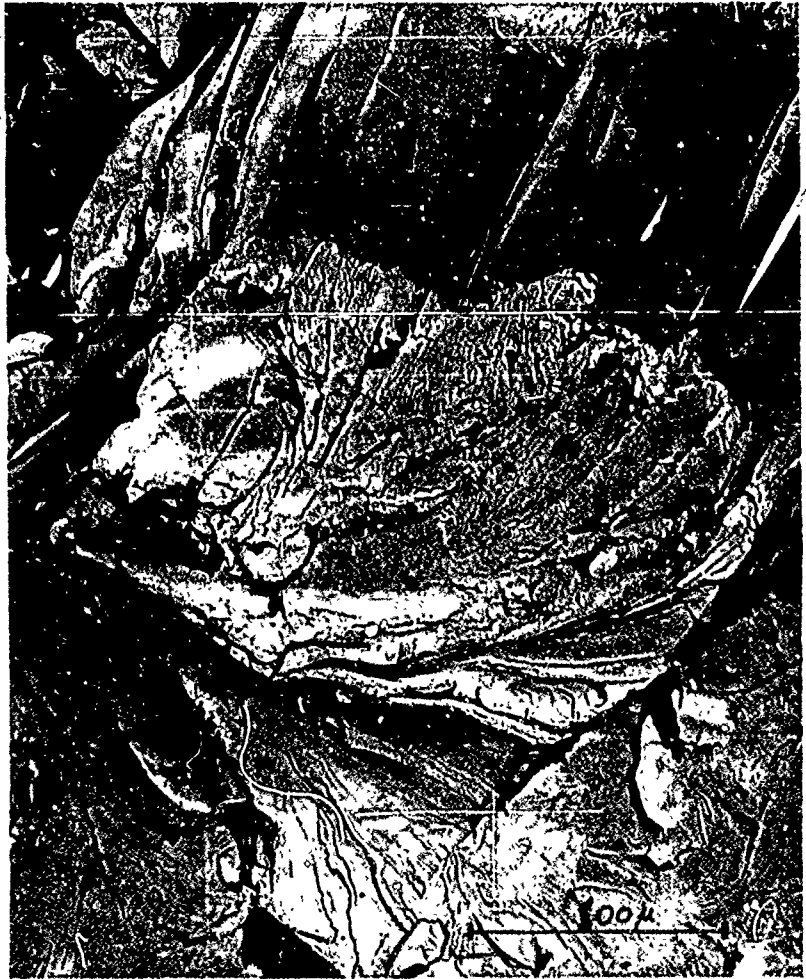
Figure 6a - ELECTRON FRACTOGRAPH SHOWING CLEAVAGE AND INTERGRANULAR (TOP) FRACTURE IN RECOVERED (1300°C) SPECIMEN AT 485°C.

the replica and could then be observed adjacent to and in the same plane as the cleavage facets as shown in Figure 6(a). This particular photograph was taken on a specimen which absorbed 30 in. lbs. in fracturing and was therefore essentially half way up the transition. As Figure 5 also illustrates these specimens generally ended up splitting longitudinally and bending plastically around the hammer. The longitudinal fracture surface was always completely intergranular as illustrated in Figure 6(b). The specimen used for this electron fractograph absorbed 45 in. lbs. and was almost at the top of its brittle to ductile transition.

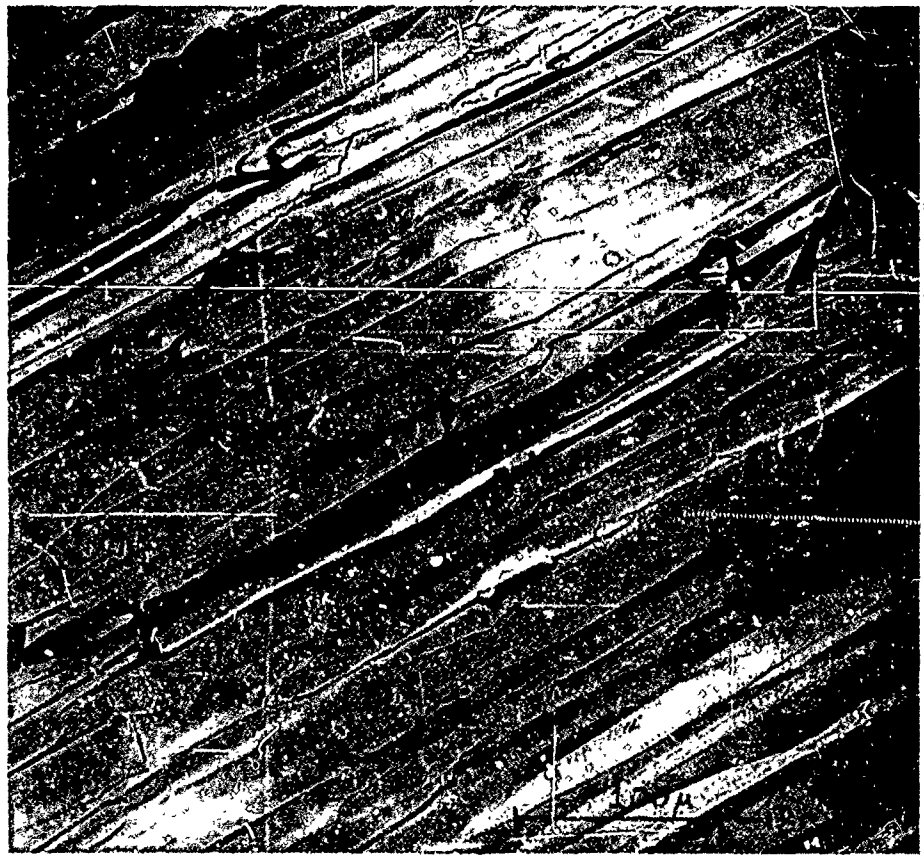
Figure 6b - ELECTRON FRACTOGRAPH SHOWING INTERGRANULAR  
SPLITTING IN WROUGHT SPECIMEN AT 450°C.

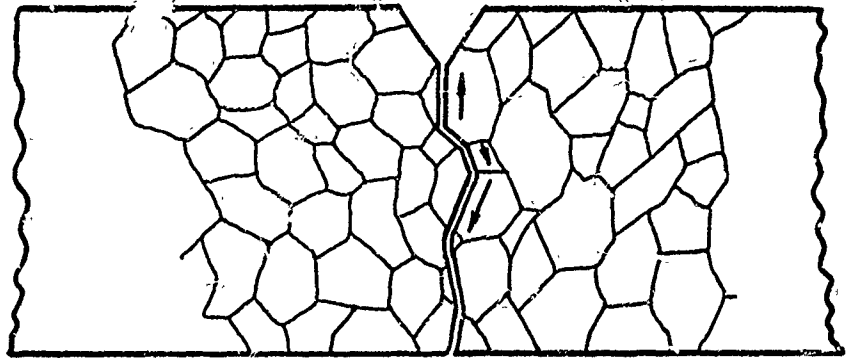
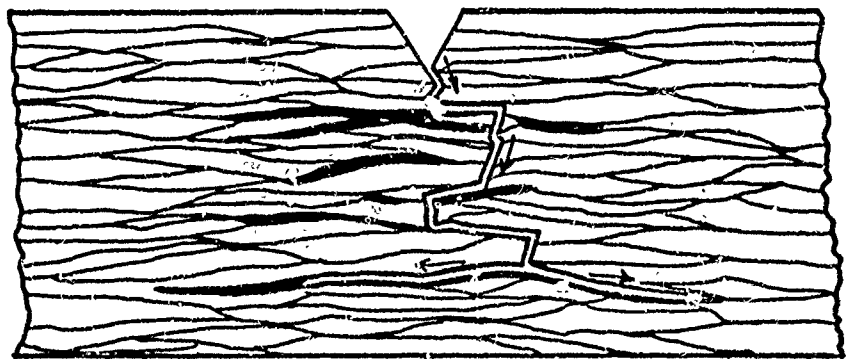
Figure 9 - FRACTURE PATH IN (a) RECRYSTALLIZED AND  
(b) WROUGHT TUNGSTEN

By comparison the sequence of events in the wrought tungsten is considered to be much more complicated. In the first place the pointed shape of the elongate grains in the fibrous structure<sup>(12)</sup> meant that it was no longer possible for an intergranular crack to nucleate in a plane perpendicular to the tensile direction within the specimen. Instead cleavage had to initiate elsewhere and in these specimens was found to originate at the surface somewhere along the line of the notch, presumably due to the high stress concentration and strain rate there. At low temperatures (i. e. room temperature to 300°C) cleavage nucleated before much bending occurred and was able to propagate across the whole specimen for a simple cleavage fracture normal to the tensile direction. But as the temperature approached 400°C the tungsten became more plastic, there was a delay in the nucleation of cleavage at the notch and the specimen started to bend. As a consequence of this bending and the development of a triaxial stress state beneath the notch, the specimen started to split over longitudinal intergranular surfaces as illustrated diagrammatically in Figure 9(b). Thus when cleavage eventually nucleated at the notch it ran into intergranular fissures and the fracture path was deflected locally into a plane parallel with the tensile direction. The fracture sequence then had to start all over again but this time under less severe loading conditions, because first, the notch effect had been eliminated and second, the strain rate had been lowered due to the reduced specimen

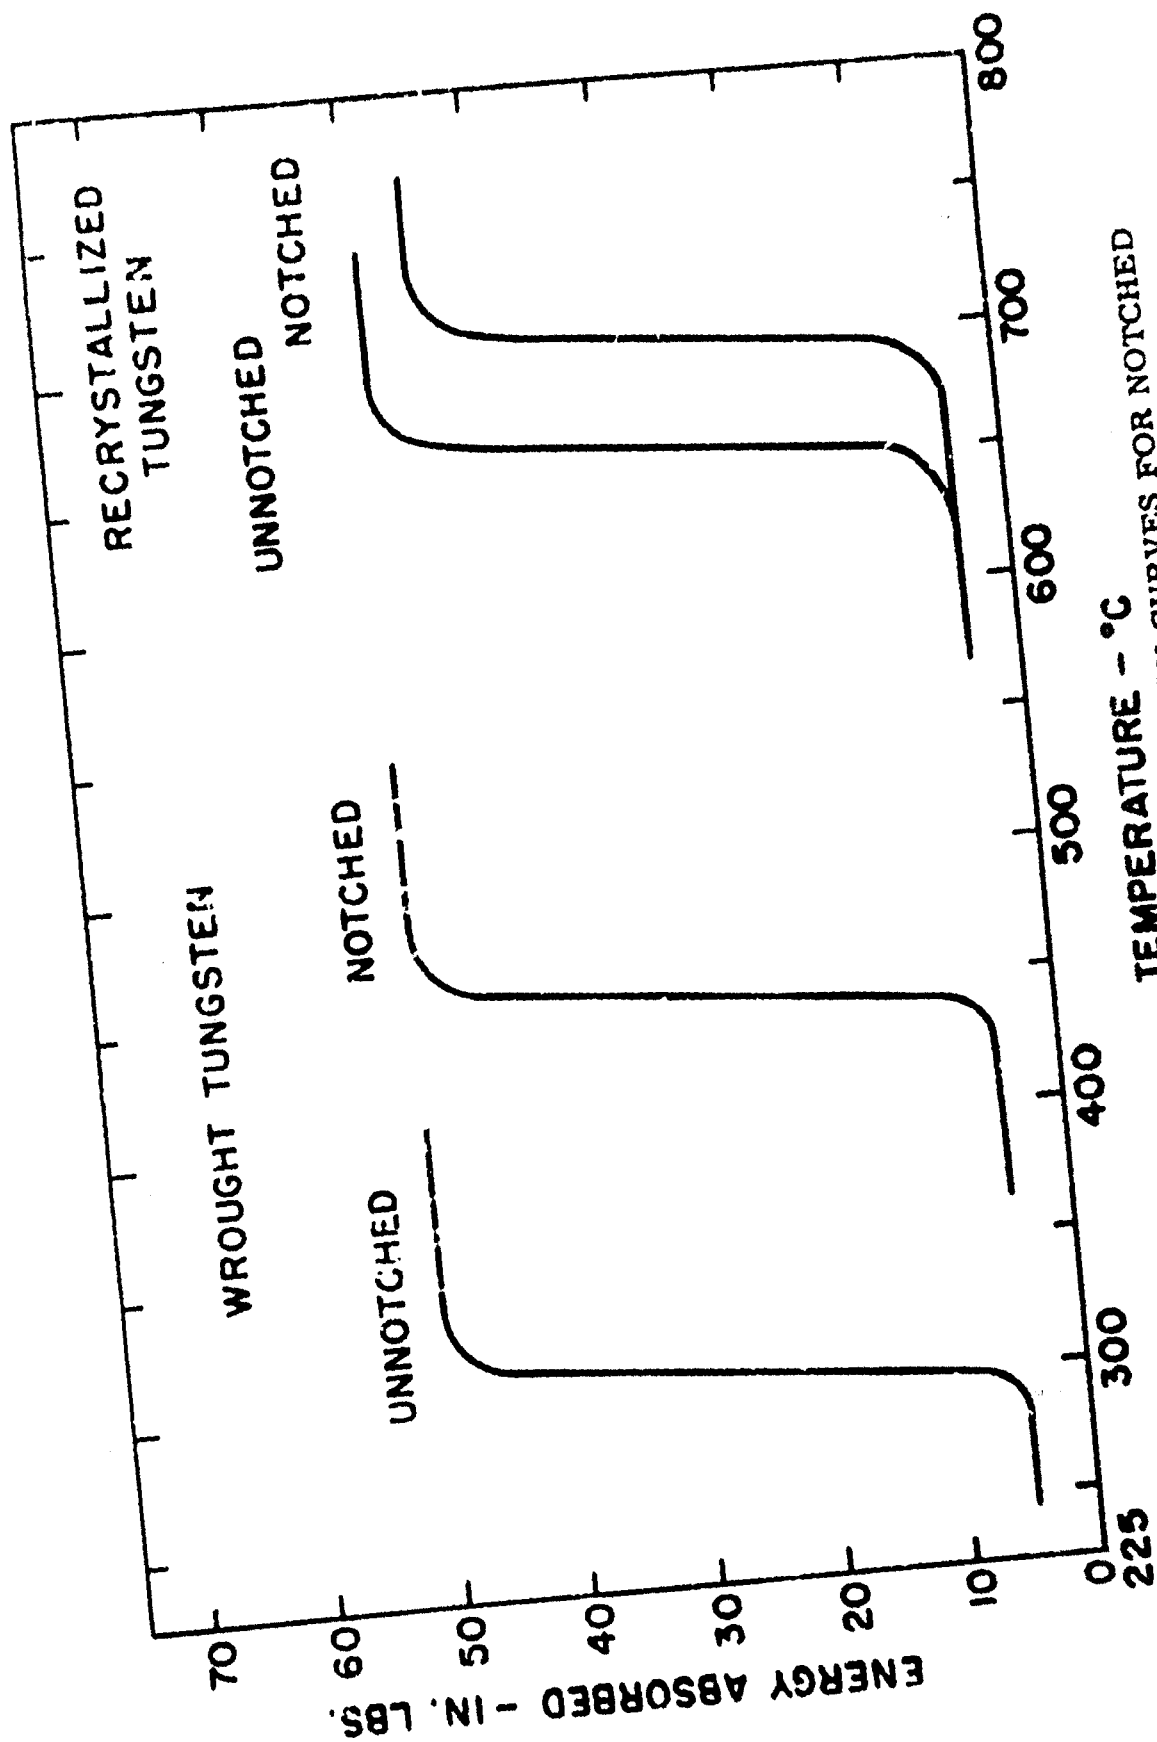
Figure 10 - DUCTILE-BRITTLE TRANSITION CURVES FOR NOTCHED AND UNNOTCHED TUNGSTEN

from which cleavage spreads. Eliminating the notch does not remove this intrinsic fracture source and is not expected to have much effect on the ductile-brittle transition behavior of recrystallized tungsten. For wrought material on the other hand the notch not only serves to concentrate the stress but also provides the initial source of cleavage. Eliminating the notch in this case is expected to have a much greater effect on the ductile-brittle transition. Experiments have established that this is in fact the case. As Figure 10 shows, the ductile-brittle transition temperature for unnotched tungsten rods recrystallized at 1610°C for 1/2 hour was measured to be 650°C, a drop of 50°C from the transition temperature for notched recrystallized material. For wrought (as-received) material on the other hand the transition temperature dropped by 140°C (to 300°C) when the notch was eliminated. In addition the wrought material no longer showed the same spectrum of fracture behavior described earlier, once cleavage nucleated at the free surface it propagated virtually without interruption across the specimen. Longitudinal splitting and bending around the hammer illustrated in Figure 5 never occurred with unnotched specimens. This was to be expected since there was no change in loading conditions as fracture propagated through the specimen. The unnotched recrystallized material still fractured by cleavage from an intergranular source located just beneath the surface. In this respect the impact strength of wrought tungsten is more notch sensitive than recrystallized tungsten and therefore more likely to be dependent on surface condition. However, wrought tungsten, notched or unnotched, is always tougher than recrystallized material.
